## Creativity Hub

ATUSS LOOK-UP! Ferrara Strategy

# Site Visit Notebook

Civic monitoring visit on 9 October 2026

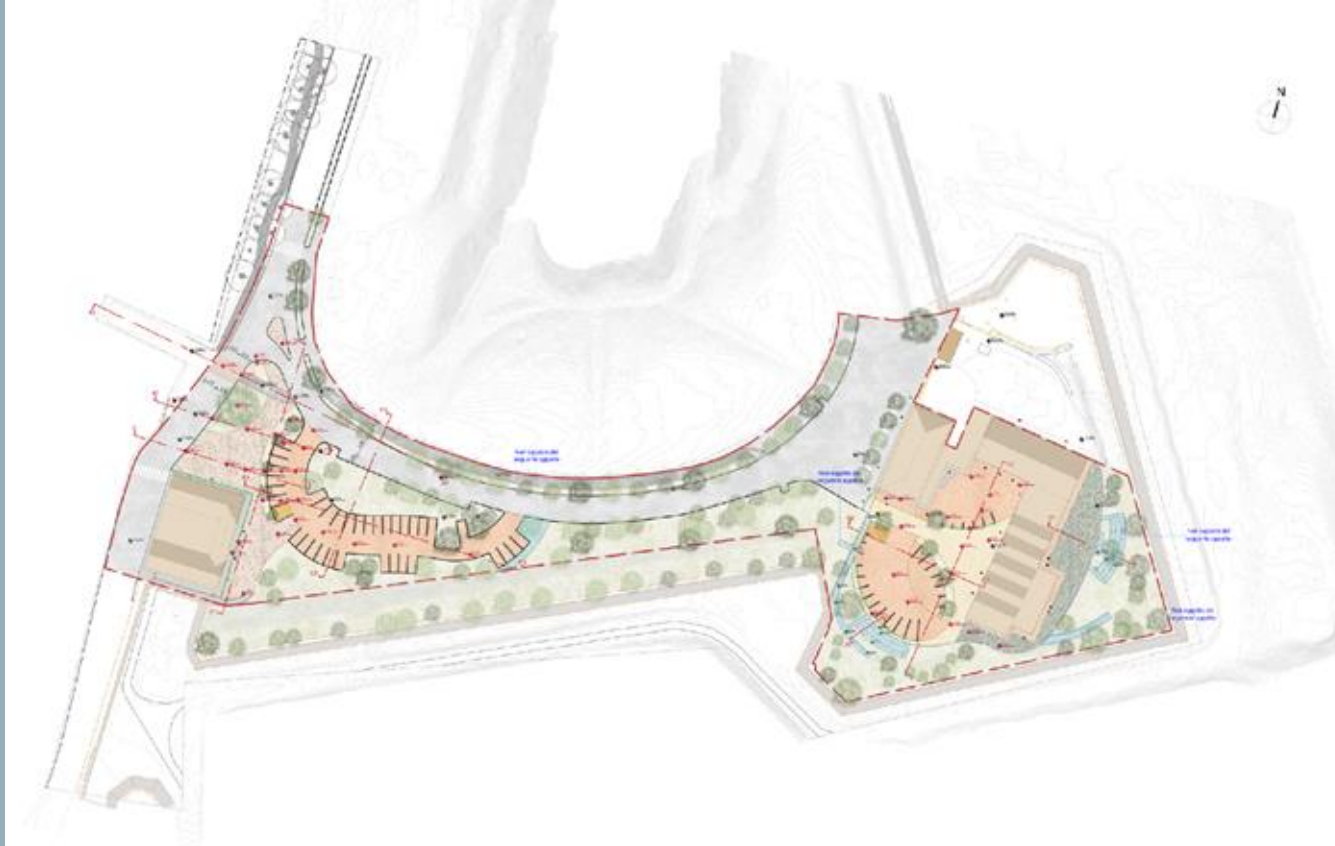
Bagno Ducali on the left. Centro Slavich and forecourt on the right.  
Design plan, distinct from the conditions observed on 9 October.

Between Bagno Ducali and the Montagna bastion, the project reorganises outdoor spaces already in use.

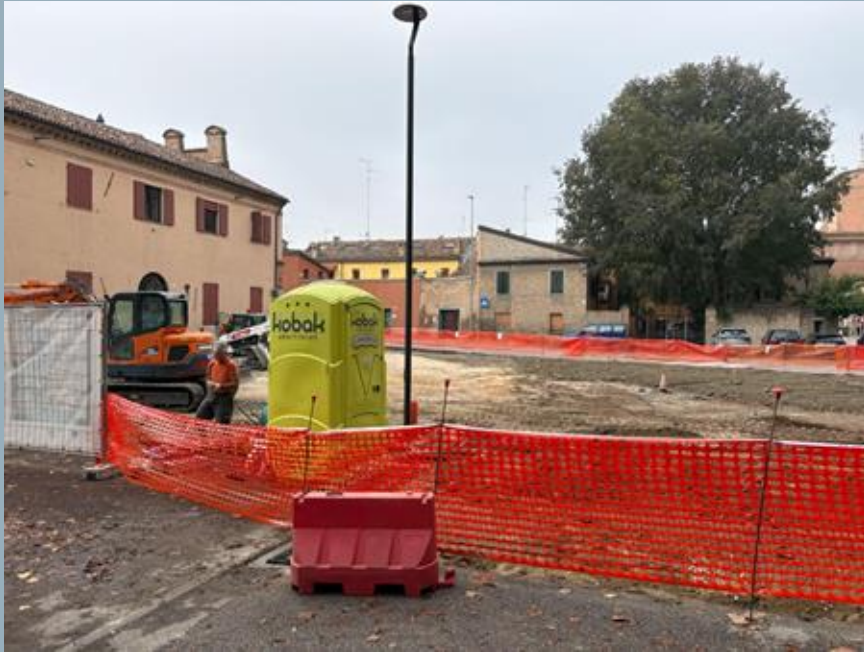
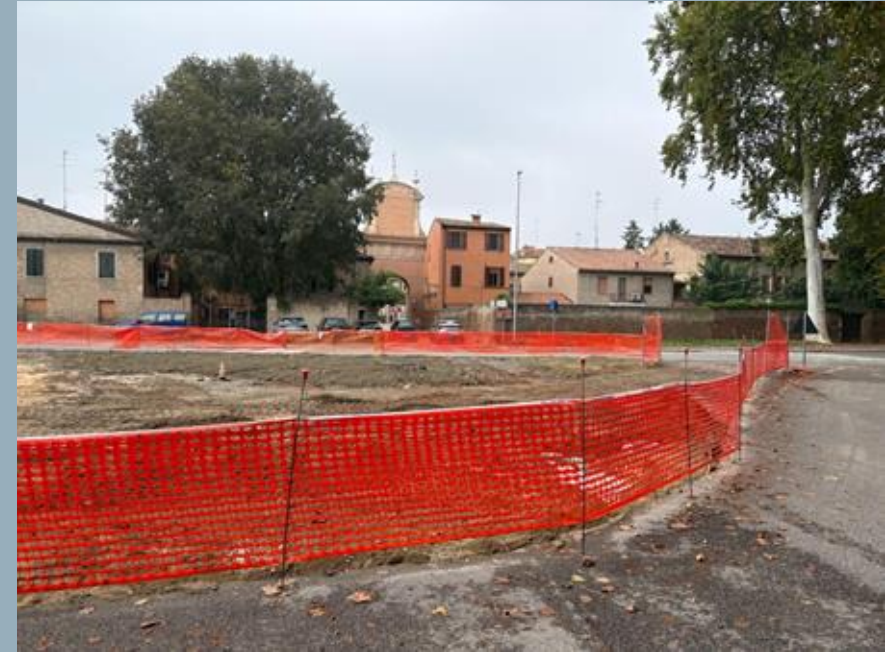
# 1. Bagni Ducali: work is still under way

On 9 October, we observe outdoor works still in progress. The works supervisor explains the aim of reclaiming an area previously also used for informal parking.

The remaining works need clarification, and crossings, connections and access points need checking. The planned conversion of the interior for the Conservatory is a separate project.

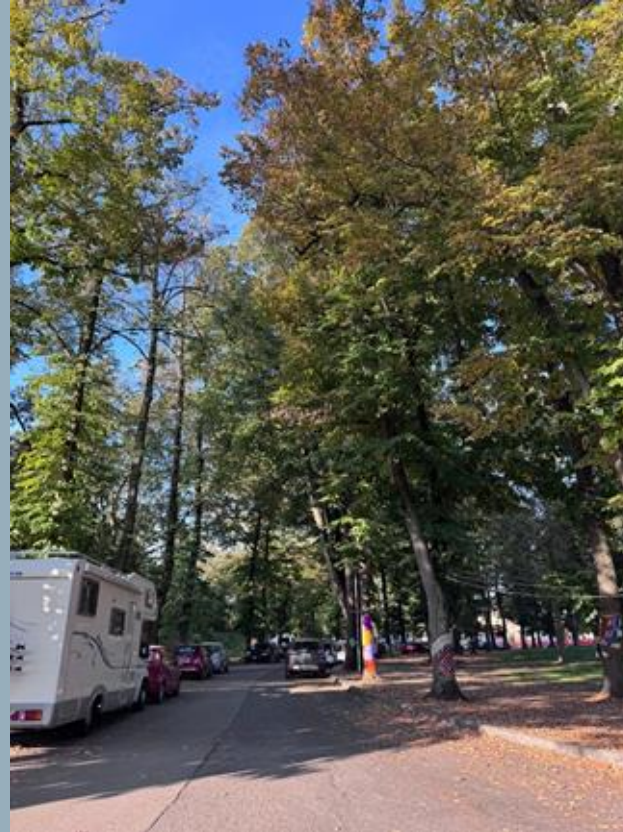
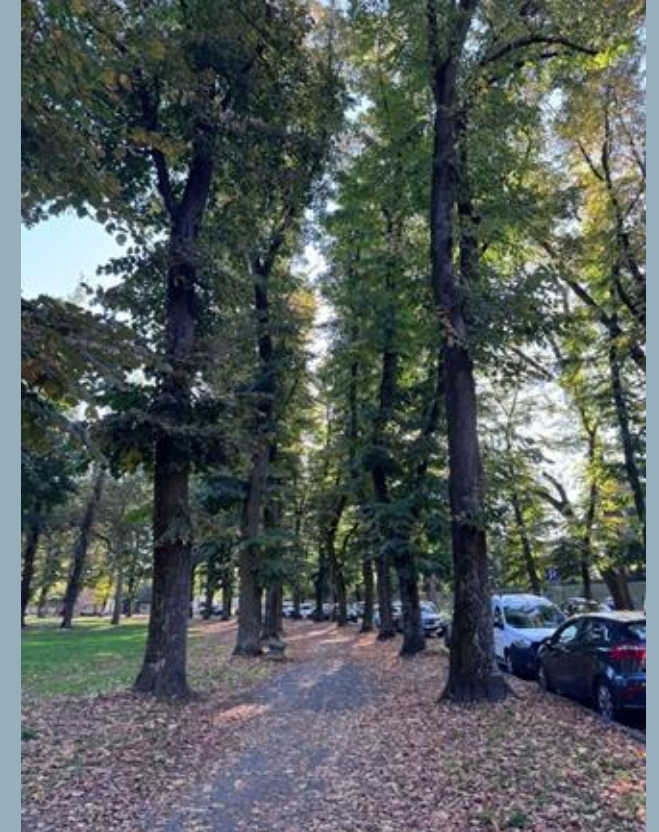
On 13 October, we sought confirmation from the project officer (RUP), who states that the parking area among the trees is complete.

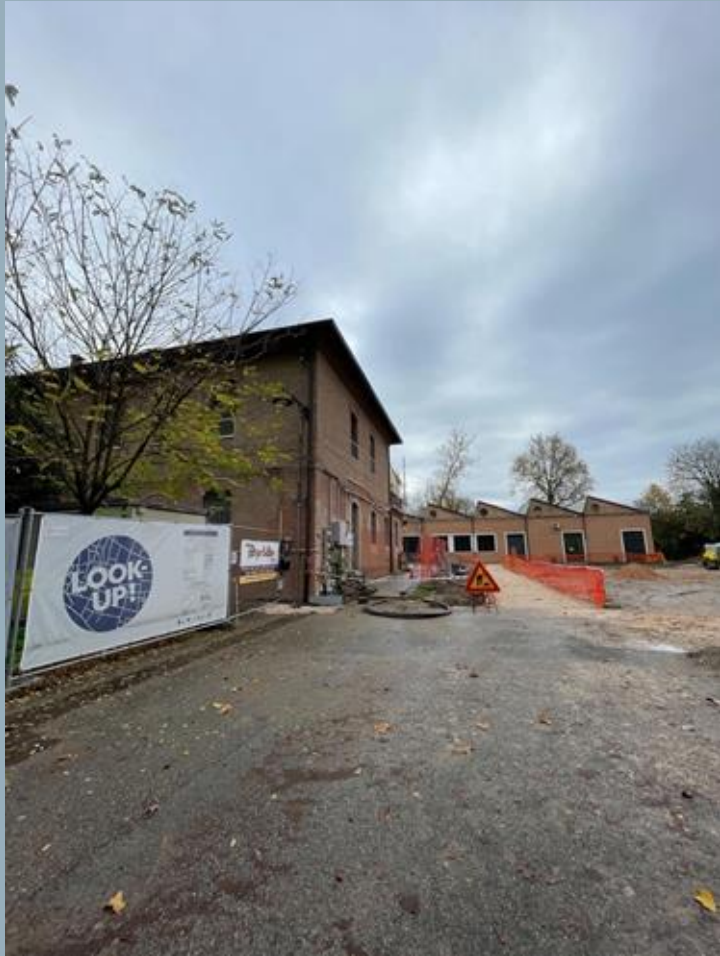
# The entrance during construction

The Council's photograph records construction at the entrance to the complex. It shows work on the forecourt, temporary fencing and utility equipment along the façade.

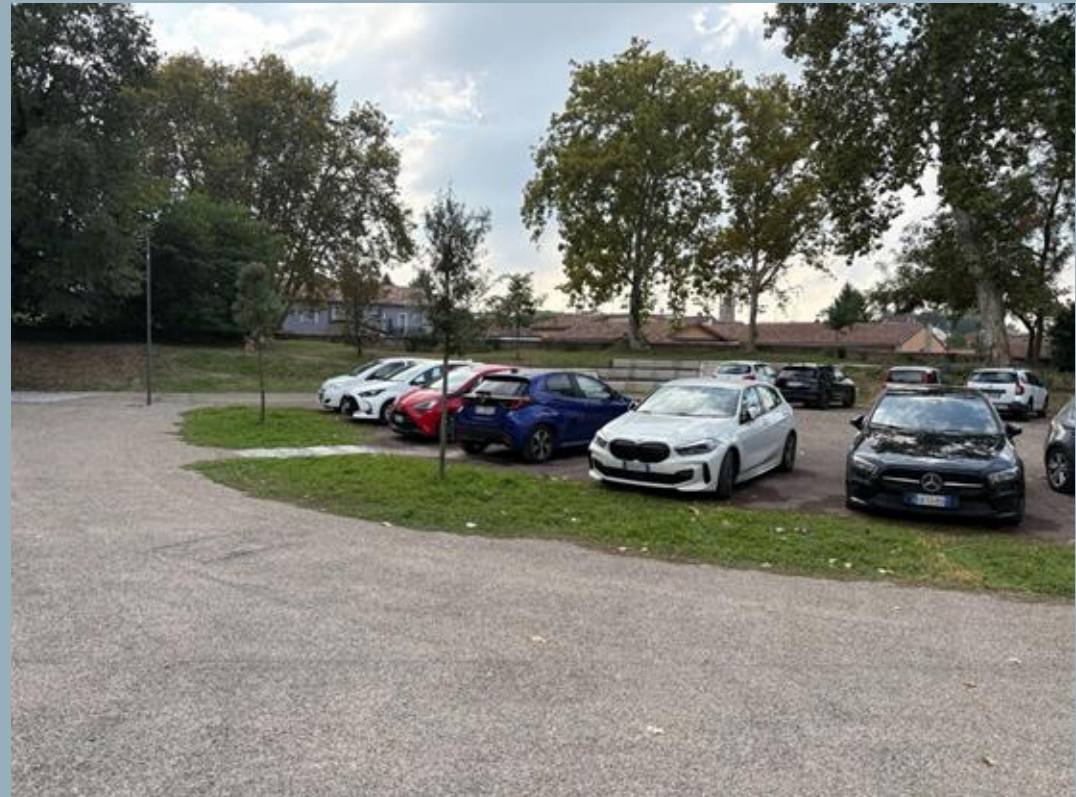
The interviews identify a specific problem: when cars occupy spaces outside entrances, some vehicles cannot get close enough to drop off people with limited mobility or unload instruments.

The cars observed show the parking arrangements.  
The photo does not record a test with passenger transport vehicles.

One suggestion is to keep a clear strip in front of the premises. This needs technical assessment and tests with the vehicles actually used.

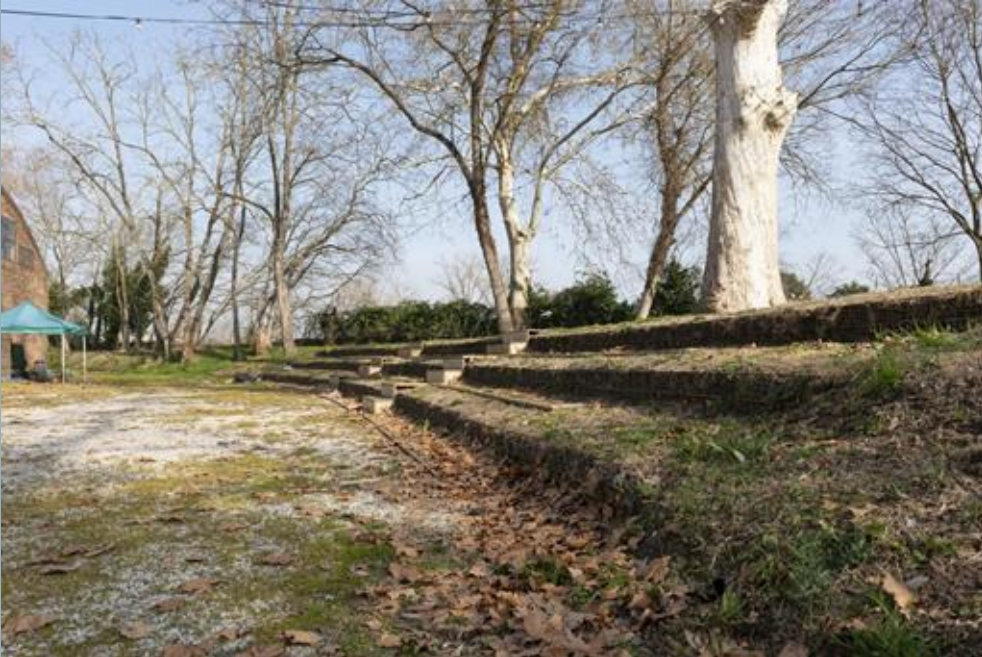
## Before redevelopment

The Council's photograph shows the previous earth surface. Date not specified.

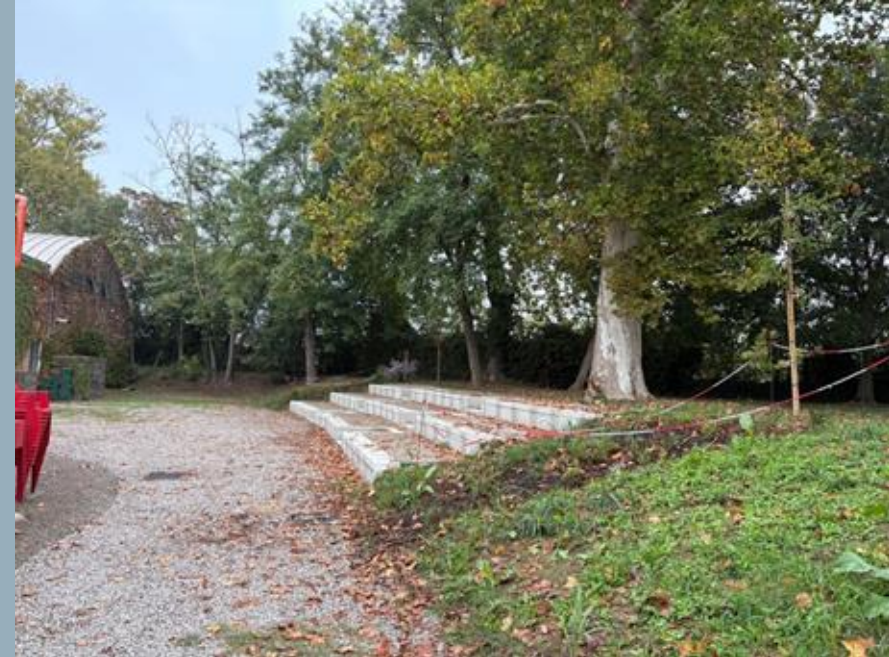
## Site visit on 9 October 2026

The visit shows the new precast elements. Photos taken from different viewpoints.

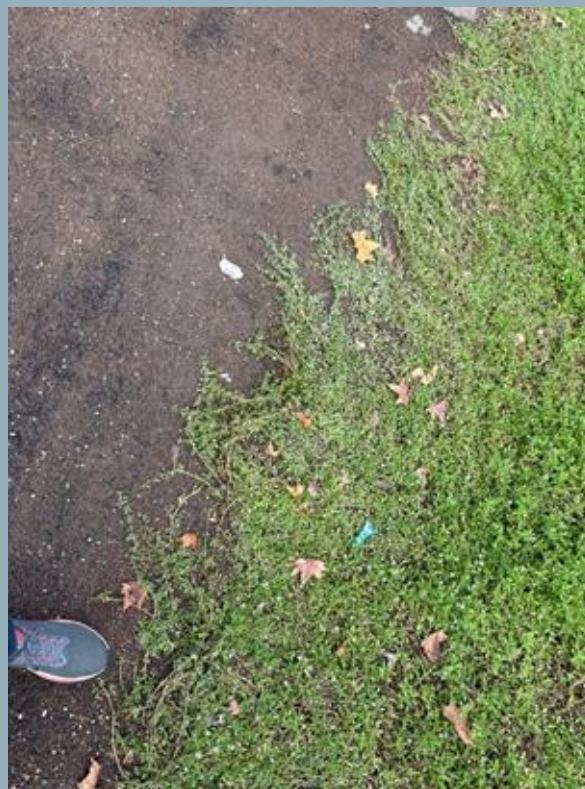
# Planting needs time and care

New trees and planting beds line the forecourt. The supervisor reports replacing two plants.

Users describe intense summer heat and still limited shade. The plants will need time and maintenance to grow.

The works supervision team names the Council and Ferrara Tua. An agreement with the associations is being drafted. Responsibilities and arrangements still need clarification.

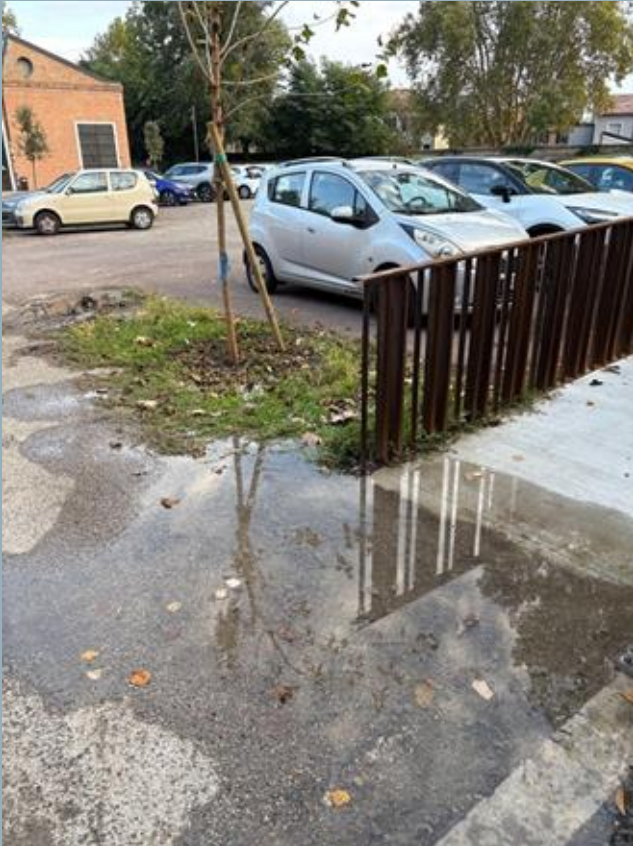
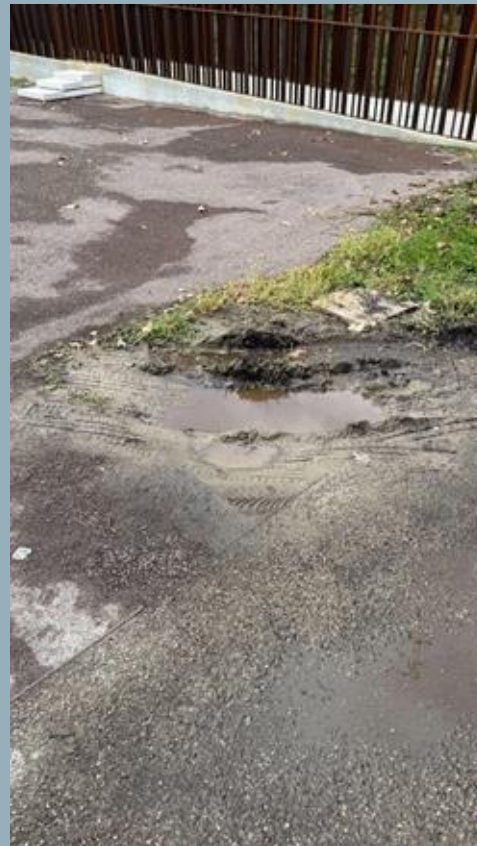
# Water: separate incidents

We noticed a puddle and a trickle of water linked to a broken pipe. The incident needs to be located and its cause clarified.

Reports of standing water during rainfall concern the performance of the drainage system.

The supervisor reports removing protective covers from drainage channels to resolve standing water. A check after rainfall is needed.

A photo records the water present. Establishing the cause requires information about the incident.

Check drainage after rainfall and lighting in the evening, distinguishing the incidents and areas concerned.
